Manhole Inspection Summary

Manhole # S67K__002MH

Insp Date: **3/1/08 1:51 PM**

Location Address: **912 Dundalk Ave.**

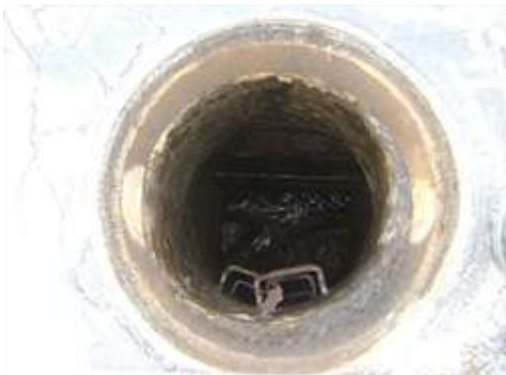
Offset: **1** (in.)

☒ **Leaks**

Frame offset defect

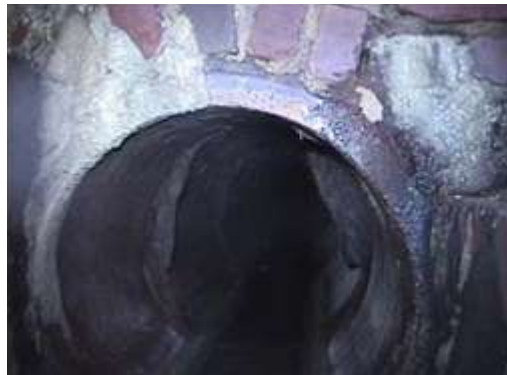
Defect 2

Infiltration: ☐ None ☐ Joint ☐ Cracks ☐ Mortar ☐ Roots ☒ **Wall**

Leaking barrel wall. 1:00 on outgoing 12 O'Clock pipe

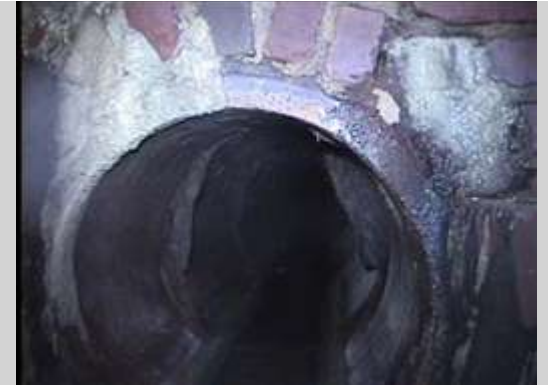
12 O'Clock Outflow

18 in. Circular Gravity Sewer
Pipe Out @ 12 O'Clock

Pipe Height: **18** (in.) Rod and Bar (Angled)
Pipe Material: **Clay** ☐ Pipe Lined
Invert Depth: **15.17** (ft.) Flow Characteristics: **Fast**
Deposits: ☒ None ☐ Mud ☐ Sludge ☐ Debris ☐ Grease
Silt Depth: (in.) Deposits Extent:
Infiltration: **Evidence** Pipe Seal Cond: **Cracked**

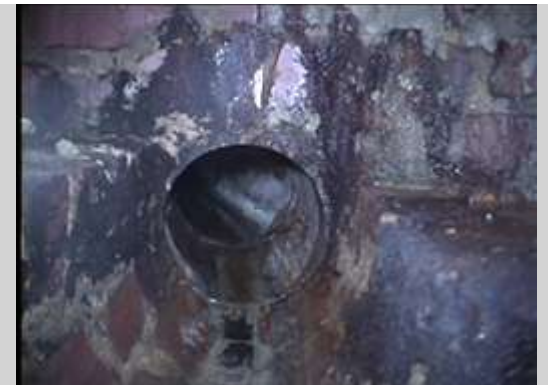
4 O'Clock Inflow

8 in. Circular Gravity Sewer
Pipe In @ 4 O'Clock

Pipe Height: **8.4** (in.) Rod and Bar (Angled)
Pipe Material: **Clay** ☐ Pipe Lined
Invert Depth: **14.58** (ft.) Flow Characteristics: **Fast**
Deposits: ☐ None ☐ Mud ☒ **Sludge** ☐ Debris ☐ Grease
Silt Depth: **0.25** (in.) Deposits Extent: **Light**
Infiltration: **None** Pipe Seal Cond: **Sound**
